LANDSLIDE INVESTIGATION
THREE FALLS RANCH
ALPINE, UTAH

IGES Job No. 00608-005

July 20, 2005

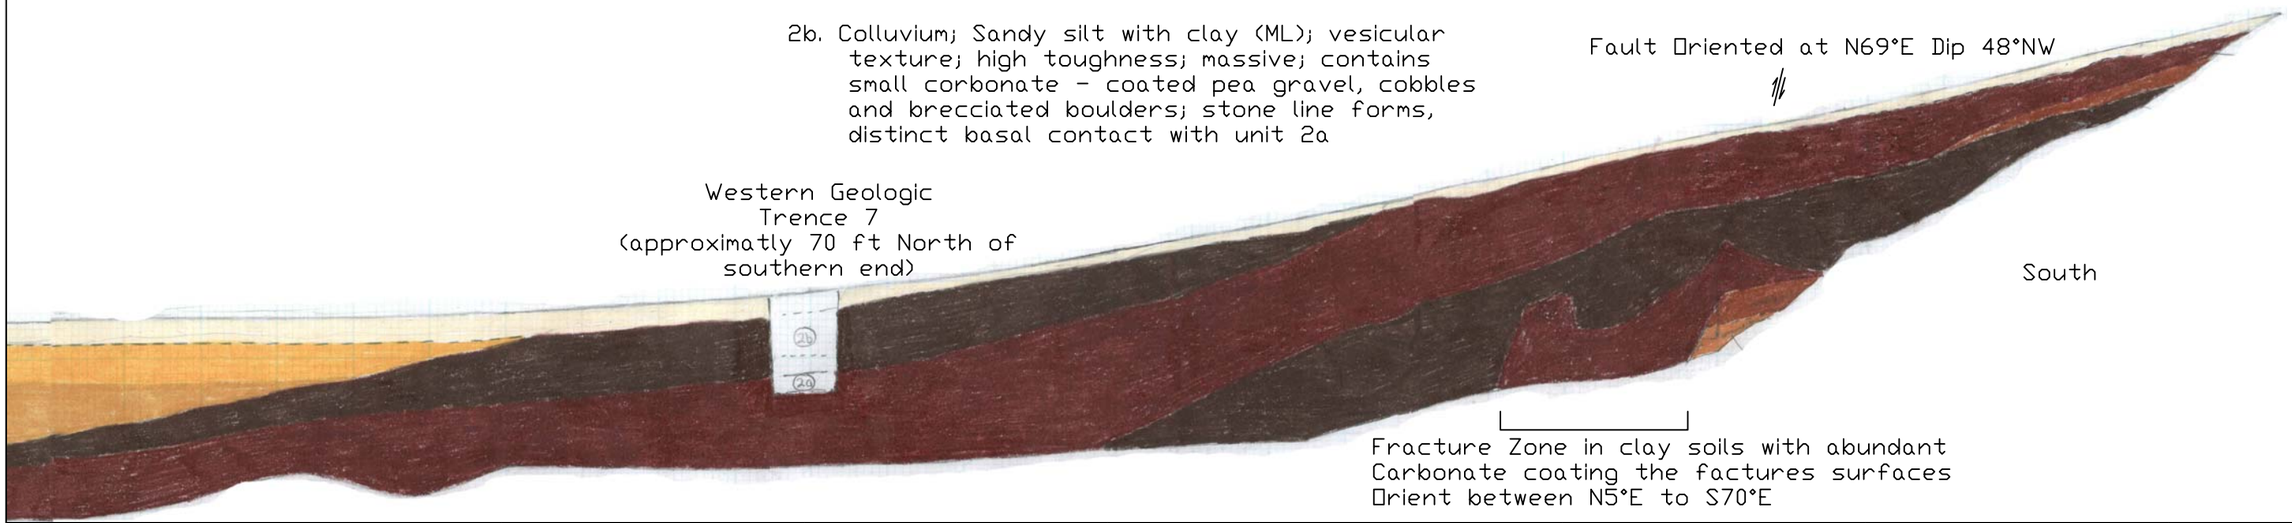
DESIGNED BY: DATE: -		APPROVED BY: DATE: -	
DRAWN BY: DATE: DLB 7/20/05		PLOT SCALE	1=1
CHECKED BY: DATE: DPN 7/20/05		DWG SCALE	1"=10'
PROJECT: 00608-005		REVISION NO:	1
DRAWING NO. -			Plate A-10a

2a. Fluidized flow; very tough
required special teeth on backhoe bucket to cut; polished to near finish in cut surface

2b. Colluvium; Sandy silt with clay (ML); vesicular texture; high toughness; massive; contains small corbonate - coated pea gravel, cobbles and brecciated boulders; stone line forms, distinct basal contact with unit 2a
